Manhole Inspection Summary

Manhole # S45C__025MH

Insp Date: **8/18/08 10:56 AM**

Location Address: **FAIRMONT**

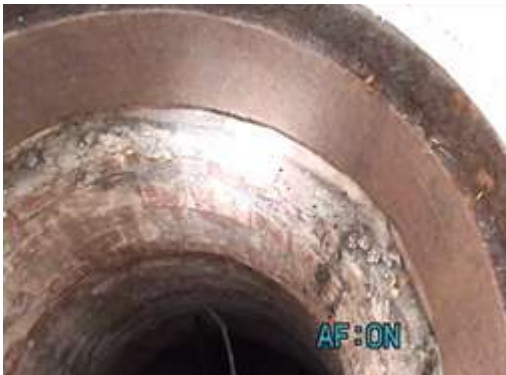
Defect 1

Infiltration: ☐ None ☐ Joint ☐ Cracks ☐ Mortar ☐ Roots ☒ **Wall**

Infiltration

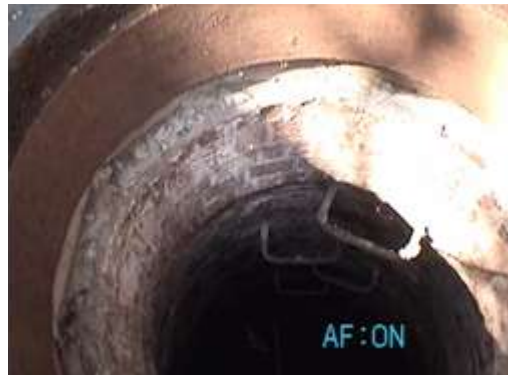
Defect 2

☒ **Leaks**

Frame leaks

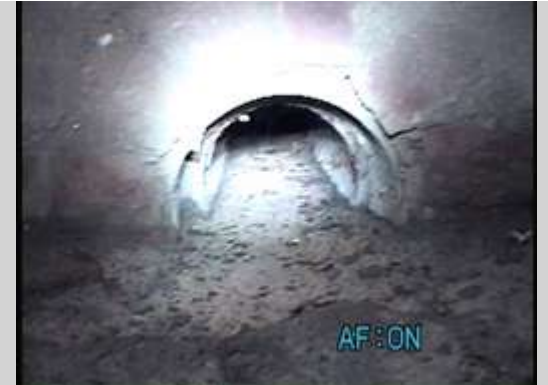
12 O'Clock Outflow

8 in. Circular Gravity Sewer
Pipe Out @ 12 O'Clock

Deposits: ☐ None ☒ **Mud** ☐ Sludge ☒ **Debris** ☐ Grease

Silt Depth: **3** (in.) Deposits Extent: **Medium**
